DELAWARE RIVER BASIN  
CHURCH RUN, GLOUCESTER COUNTY  
NEW JERSEY

**NARRATICON LAKE  
DAM  
NJ00111**

**PHASE 1 INSPECTION REPORT  
NATIONAL DAM SAFETY PROGRAM**

PHASE I REPORT  
NATIONAL DAM INSPECTION PROGRAM

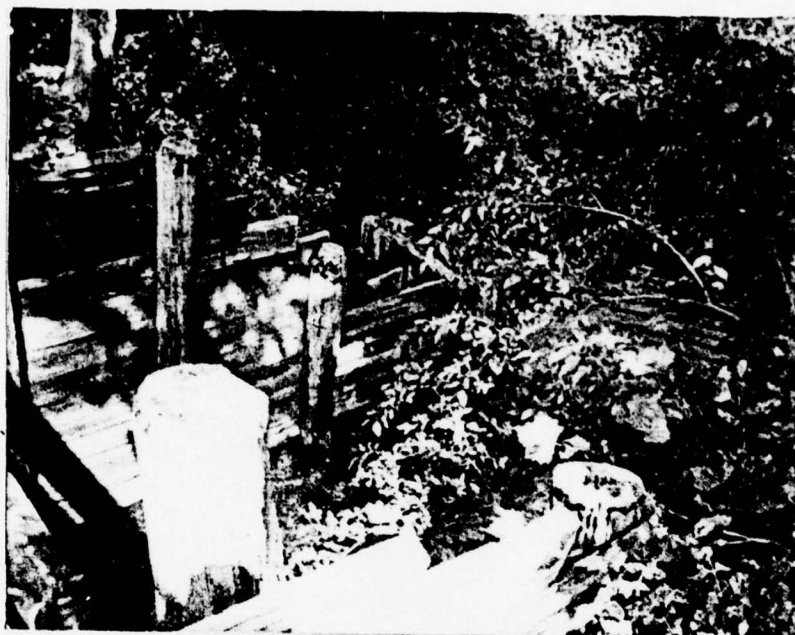
VISUAL EXAMINATION OF	OBSERVATIONS	REMARKS OR RECOMMENDATIONS
CRACKING AND SPALLING OF CONCRETE SURFACES IN OUTLET CONDUIT		
INTAKE STRUCTURE	All wood structure (some minor rotting).	
OUTLET STRUCTURE	All wood structure, heavy rotting of wooden planks particularly on side walls, irregular surface from warping, 3" $\phi$ tree growing through East wall.	
OUTLET CHANNEL	Meandering natural channel heavily wooded, minor debris.	
EMERGENCY GATE	None - Old 8' wide spillway at right abutment, deteriorated concrete, west to old mill raceway, leads to 5' RCP under roadway.

Spillway outlet structure

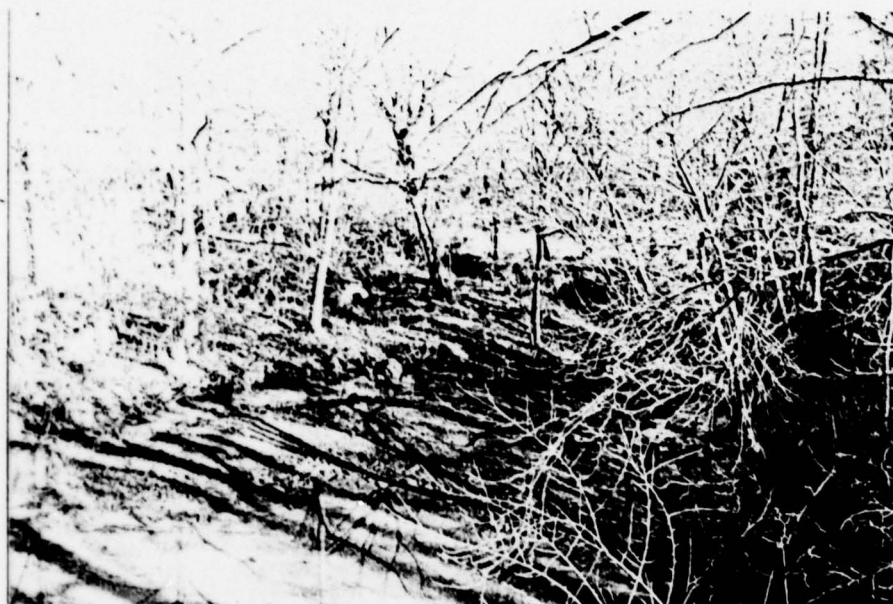
VISUAL EXAMINATION OF	OBSERVATIONS	REMARKS OR RECOMMENDATIONS
CONDITION (OBSTRUCTIONS, DEBRIS, ETC.)	Some debris	
SLOPES	Approximately 200' flood plain then steep slopes up to town roads.	
APPROXIMATE NO. OF HOMES AND POPULATION	None immediately below dam. All residences and buildings well above dam crest elevation.

Downstream channel

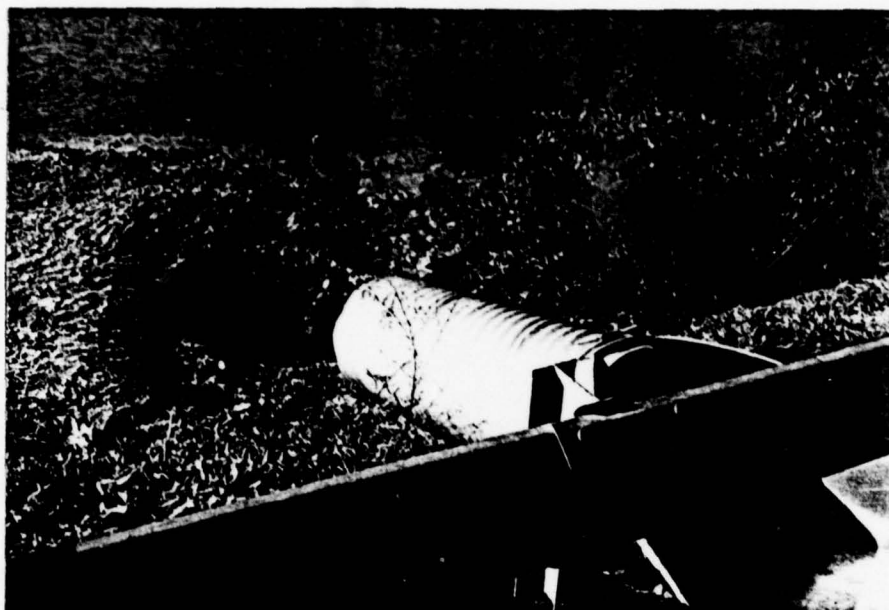
The roadway embankment which forms the main dam structure, was assessed to be in a solid and stable condition although pavement run-off at the gutter lines causes a continual maintenance problem, especially on the upstream side. A corrugated metal curb inlet has recently been installed just to the right of the spillway to alleviate this problem but a considerable portion of the upstream slopes in this area have been washed out. The roadway profile is on a sag vertical curve crossing over the dam and it appears there is considerable settlement in the vicinity of the CMP curb inlet. Although there are a few trees on the upstream face, the downstream backslope is heavily wooded with several larger trees. There is no evidence of riprap along the embankment structure but the backslopes have stabilizing ground cover. Heavy seepage was observed on each side of the timber bridge abutments and under the timber apron on the outlet end. This is apparently caused by piping in and around the timber structure. Additionally, other lower portions of the downstream backslope were damp which might be expected in the stratified alluvium foundation material found predominantly throughout this area. The abutment zones are ill-defined as the roadway rises up and the embankment broadens out and blends into the original terrain. The north curb line of the road is straight and is in good alignment,

Roadway drain pipe

- The upstream slopes of the dam embankment should be regraded, compacted and protected, especially in the vicinity of the CMP curb drain.
- The trees should be removed from the dam slopes and the disturbed areas regraded, compacted and seeded.
- The deck planking on the walkway over the spillway should be replaced as it constitutes a potential danger to operating personnel.

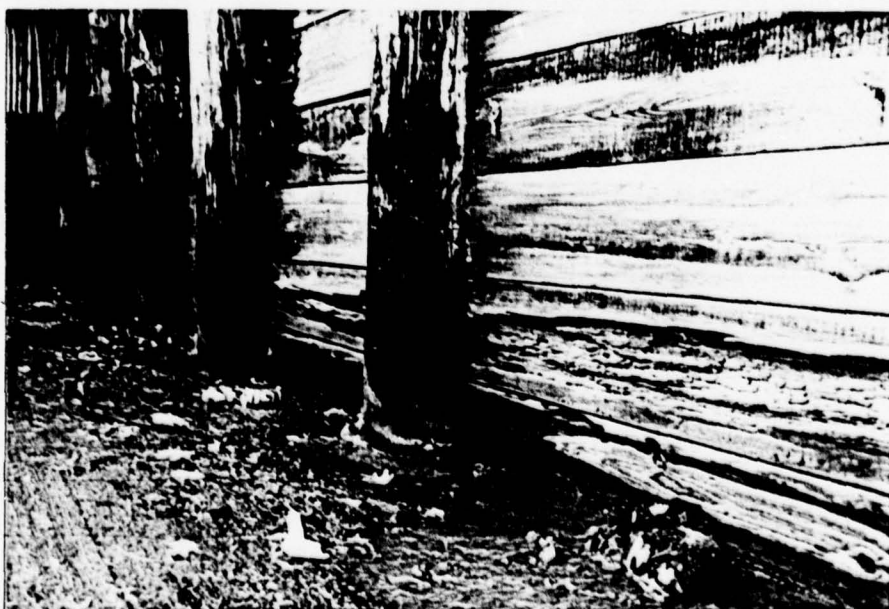
The timber bridge is in an advanced stage of decay and should be replaced. There is evidence of seepage in and around the entire substructure and the apron plank slab is rotted out with pieces missing and is undercut on the downstream end. The timber box spillway portion abutting the bridge is in an adequate condition to be preserved on a short-term basis but it is almost 25 years old and approaching the time for replacement for timber construction. The dam embankment is judged to be in a satisfactory and stable condition as only minor seepage was observed at the bottom of the backslopes. As previously stated, the major seepage is concentrated immediately behind the timber walls of the bridge.

Rotted timber planking in spillway structure

(1) Replace the deteriorated timber planking of the walkway over the spillway.

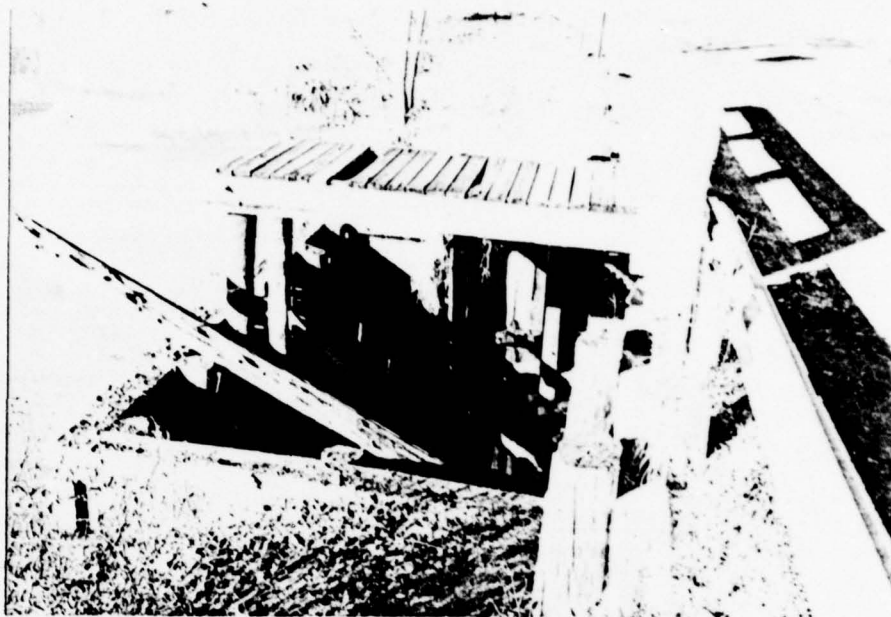
The timber bridge and spillway structure are in poor condition and exhibit advance stages of dry rot in numerous members. The superstructure carrying traffic over the ungated outlet opening has a span of 20 feet and is founded on timber piling. The 18 by 12 foot box inlet is framed and braced solidly and is in much better condition than the bridge structure. There was only minor evidence of leaking, rotting or splintering and the stoplogs in the 2'-3" removable section are equipped with lifting eyes and appear to be operable. A considerable amount of debris had collected in the drop inlet over the summer months but is of no concern to the inspection team. The downstream wingwalls and plank outfall apron beneath the bridge are in advanced stages of decay with the left bulkhead wall tilted inward several inches. The auxiliary culvert pipe near the right abutment is set at an elevation slightly below the main spillway and although functioning satisfactory, is completely deteriorated on the inlet end and has severe cracks in its concrete headwall. This culvert outlets into an ill-defined auxiliary power raceway which extends to an old abandoned mill site about 200 feet downstream.

Timber box spillway

As previously stated, it is recommended that the vehicular highway bridge be replaced in the near future.

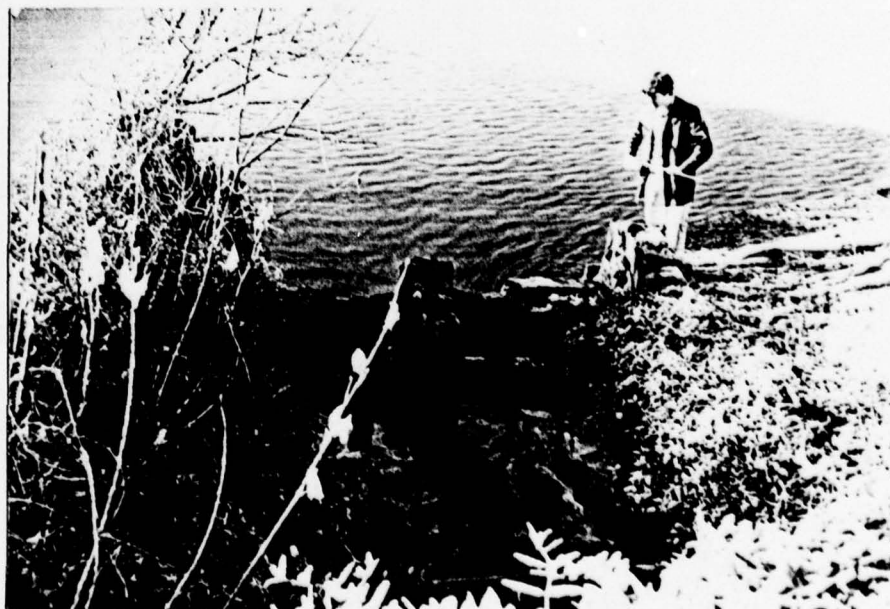
Auxillary spillway to old mill race
